Report

Investigation of corrosion on core plugs on behalf of:

Dept. of Metal and Surface Engineering
Kongsvang Allé 29
DK - 8000 Aarhus C, Denmark
Phone: 7220 2000

02.10.2015

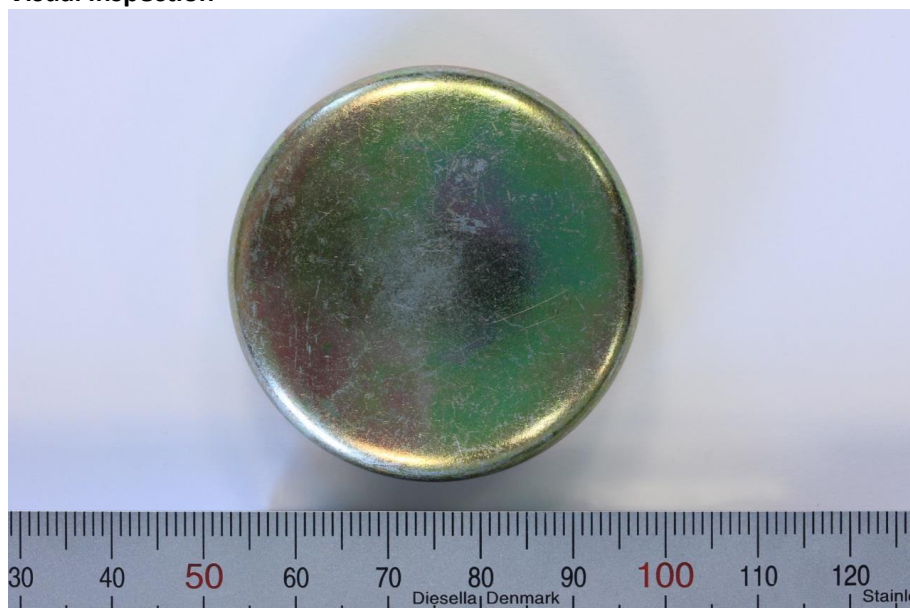
Figure 1: Inside, new unused core plug for reference.

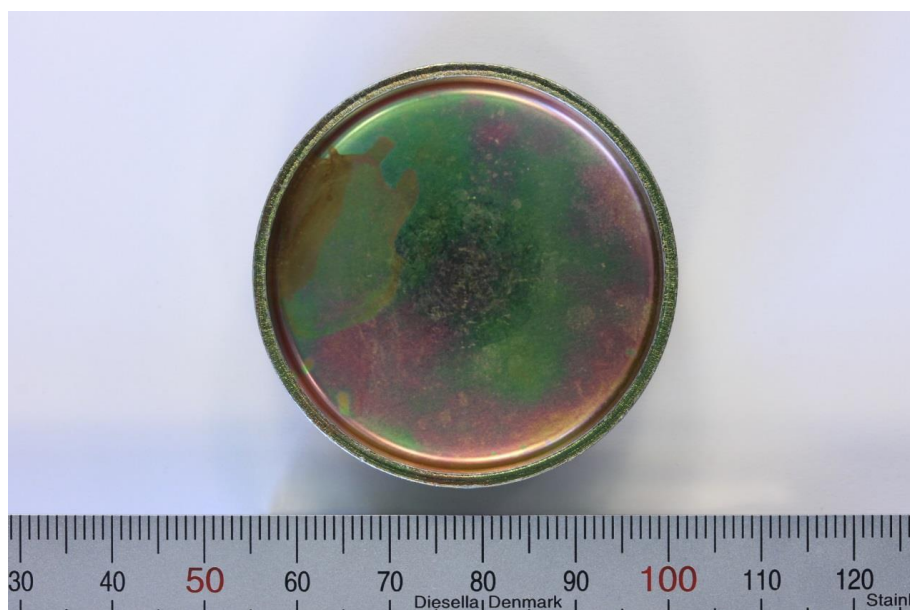
Figure 2: Outside, new unused core plug for reference.

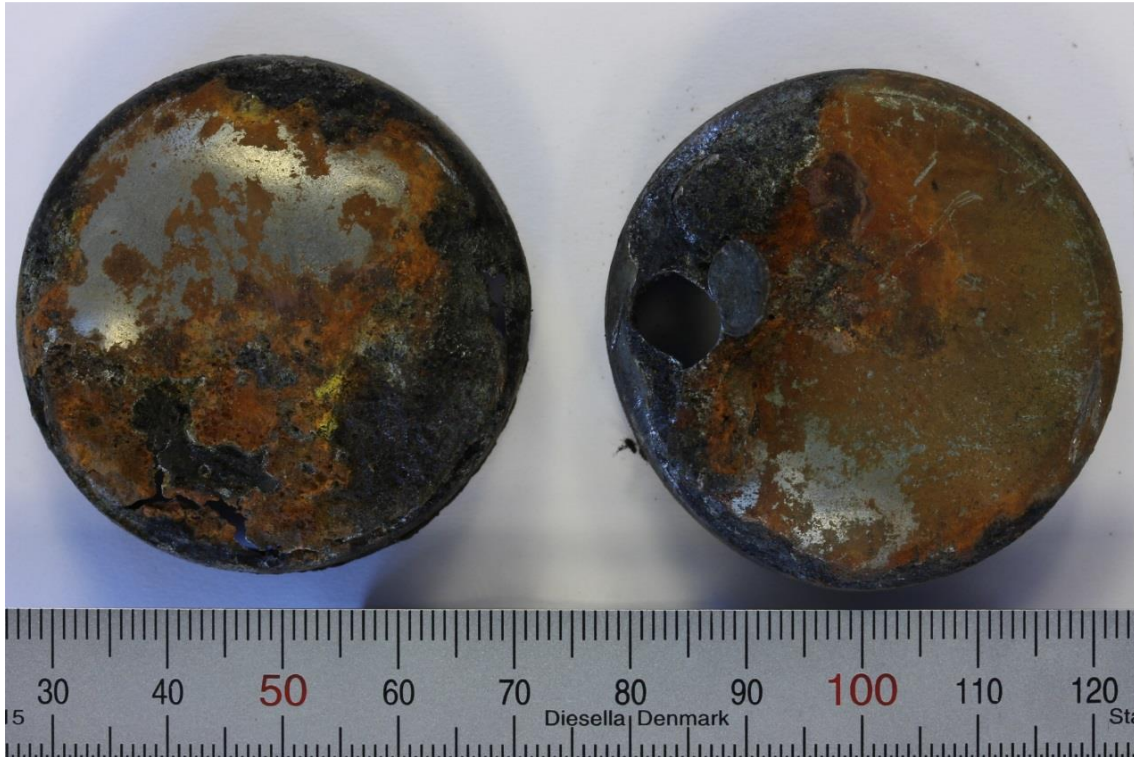
The four examined core plugs show clear signs of corrosion. The corrosion is observed in a limited area along the outer edge of the core plugs in the gap between the core plugs and the cast iron engine block. The corrosion type appears to be pitting corrosion with clear origin from the inside of the core plug (coolant side). See Annex 1.

Figure 3: Inside - 2 large core plugs from r/h side of rear engine block.

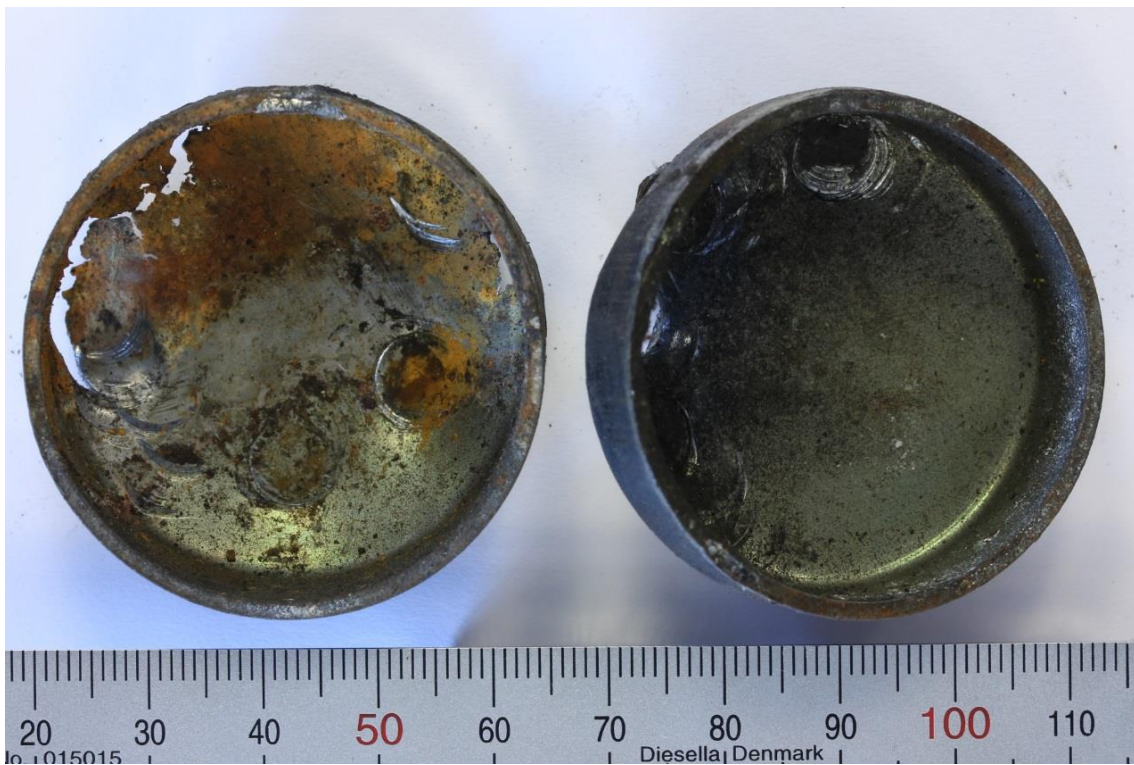
Figure 4: Outside, 2 large core plugs r/h side of rear engine block.

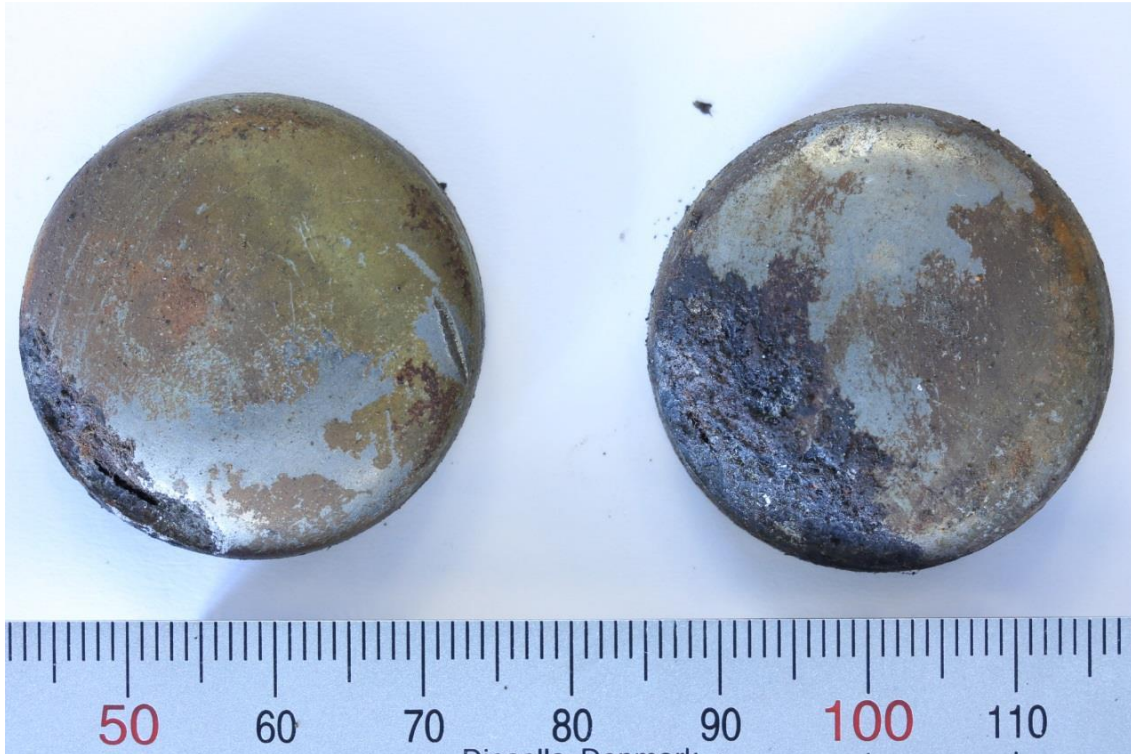
[REDACTED] is experiencing corrosion on core plugs from [REDACTED]. The corrosion has led to a seeping coolant leakage, both externally and internally in the engine, which in unfortunate circumstances might lead to a total engine failure. The engine block is stated to be made of cast iron. The customer has stated that there is no apparent pattern indicating external influence, or a difference of the corrosion depending on the location of the plugs. Some of the core plugs are fitted internally, in contact with engine oil on the outside. Nonetheless corrosion can be observed on the inside of the plugs (see figure 5 & 6).

The visual inspection of the used core plugs showed clear signs of corrosion along the outer edge of the core plug in the joint between the plug and the cast iron block. Due to the shape of the plug (rounded edges), a narrow gap between the plug and the cast iron block will be formed where particles or impurities can build up because of poor circulation. After cleaning of a core plug large grooves and material loss is observed on the inside of the core plug, indicating that the attack started on the coolant side.

The corrosion is estimated to have started on the inside (coolant side) in the narrow gap between the core plug and the cast iron block.

Figure 5: Inside - 2 small core plugs from rear cylinder head.

Further evaluation of the cause of damage will require a review of the engine's maintenance protocol, investigation of the pH values in the engine cf. the manufacturer's recommendations, compared with the observed damage.

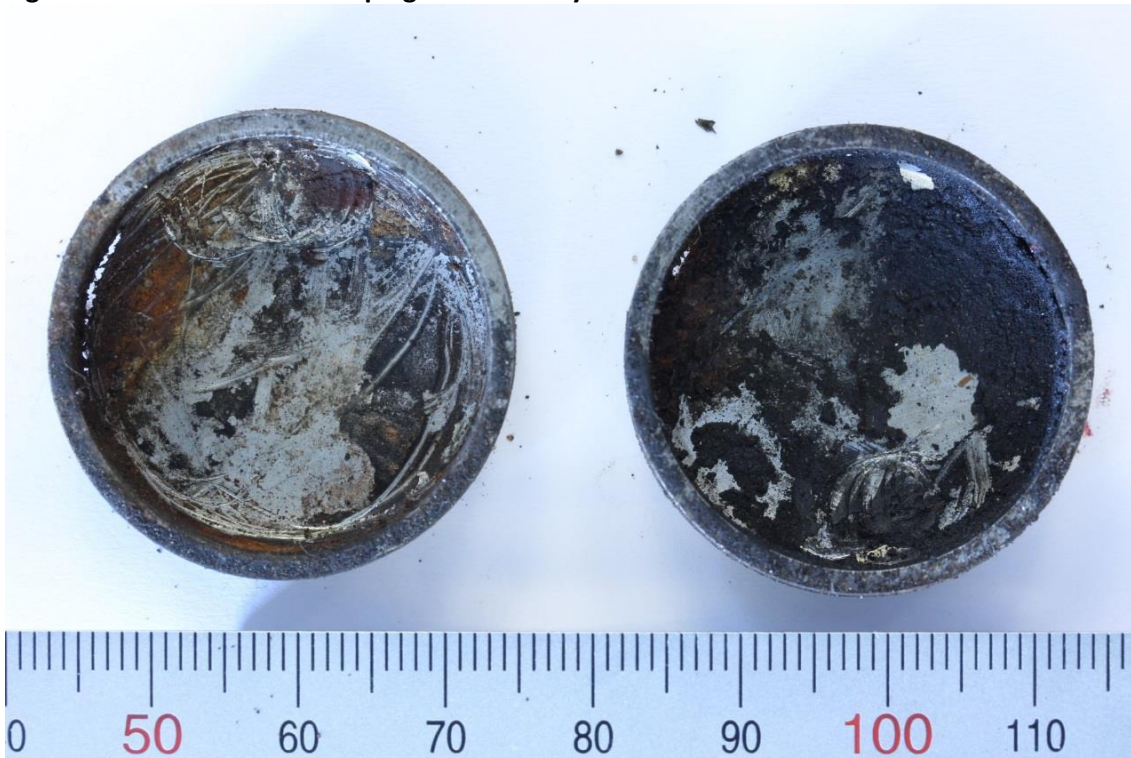
Figure 6: Outside, 2 small core plugs from rear cylinder head.

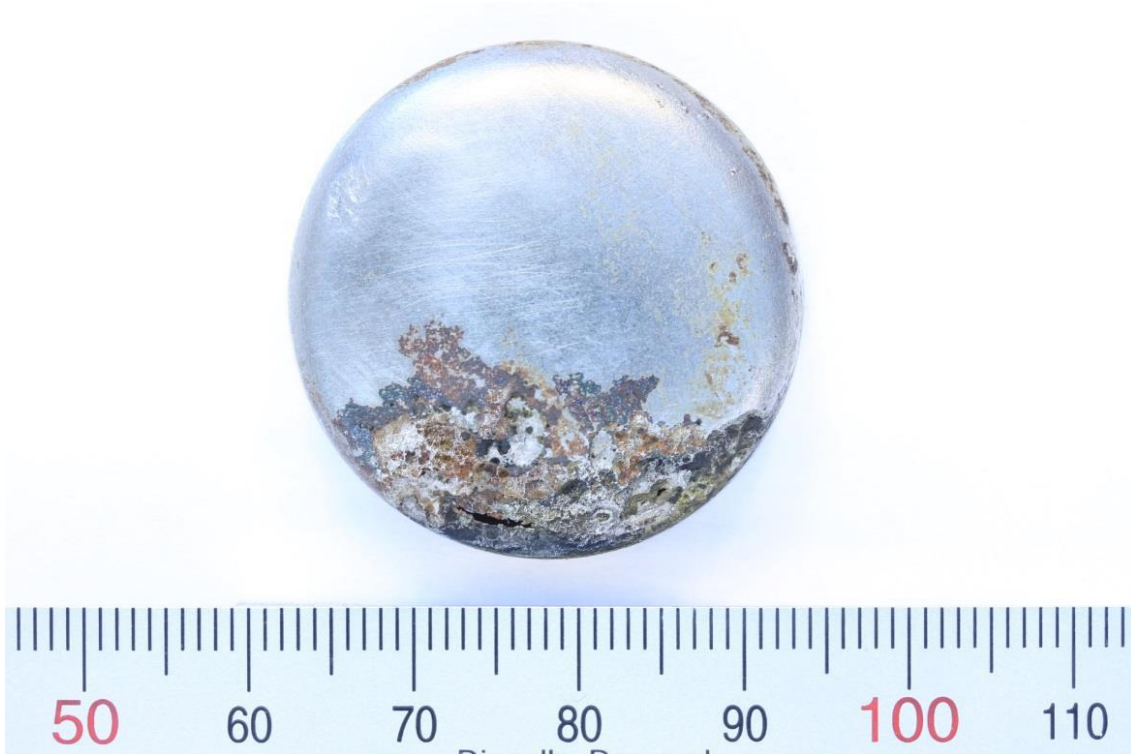
After cleaning of a used core plug, a yellowish surface corresponding to that of the new, unused reference core plug can be observed on part of the outer surface. Large grooves with material loss and in some places corrosion perforation can also be observed (see Annex 1).

Figure 7: Inside - 1 small core plug from rear cylinder head after cleaning with acetone and ultrasound.

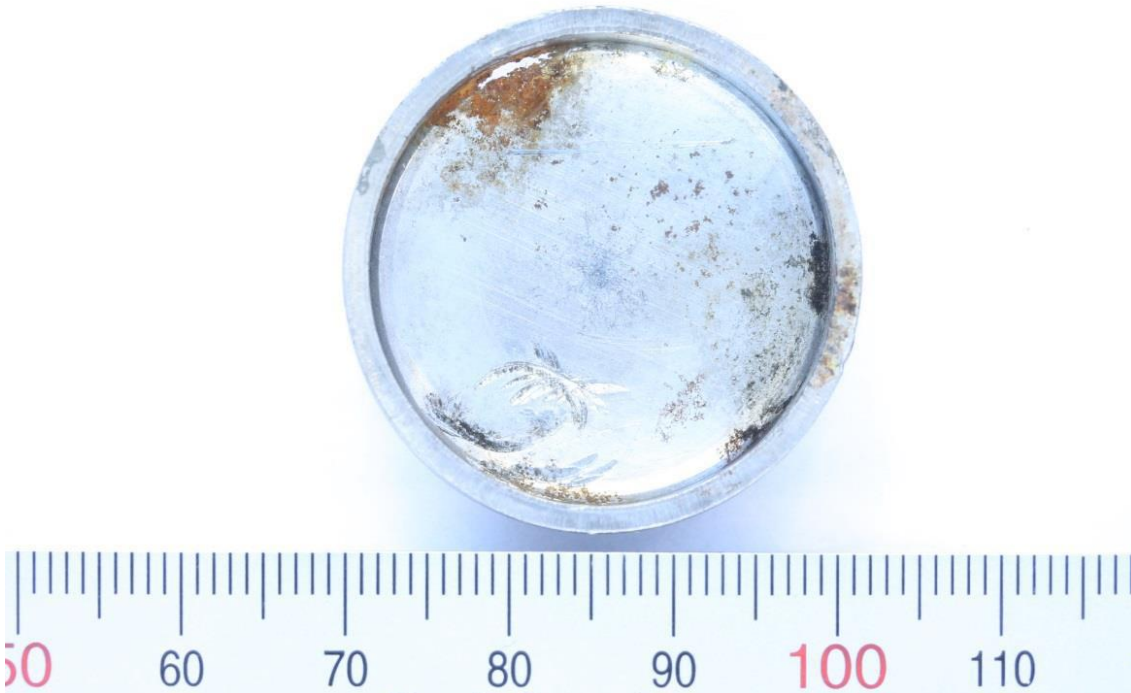
Figure 8: Outside, 1 little core plug from rear cylinder head after cleaning with acetone and ultrasound.

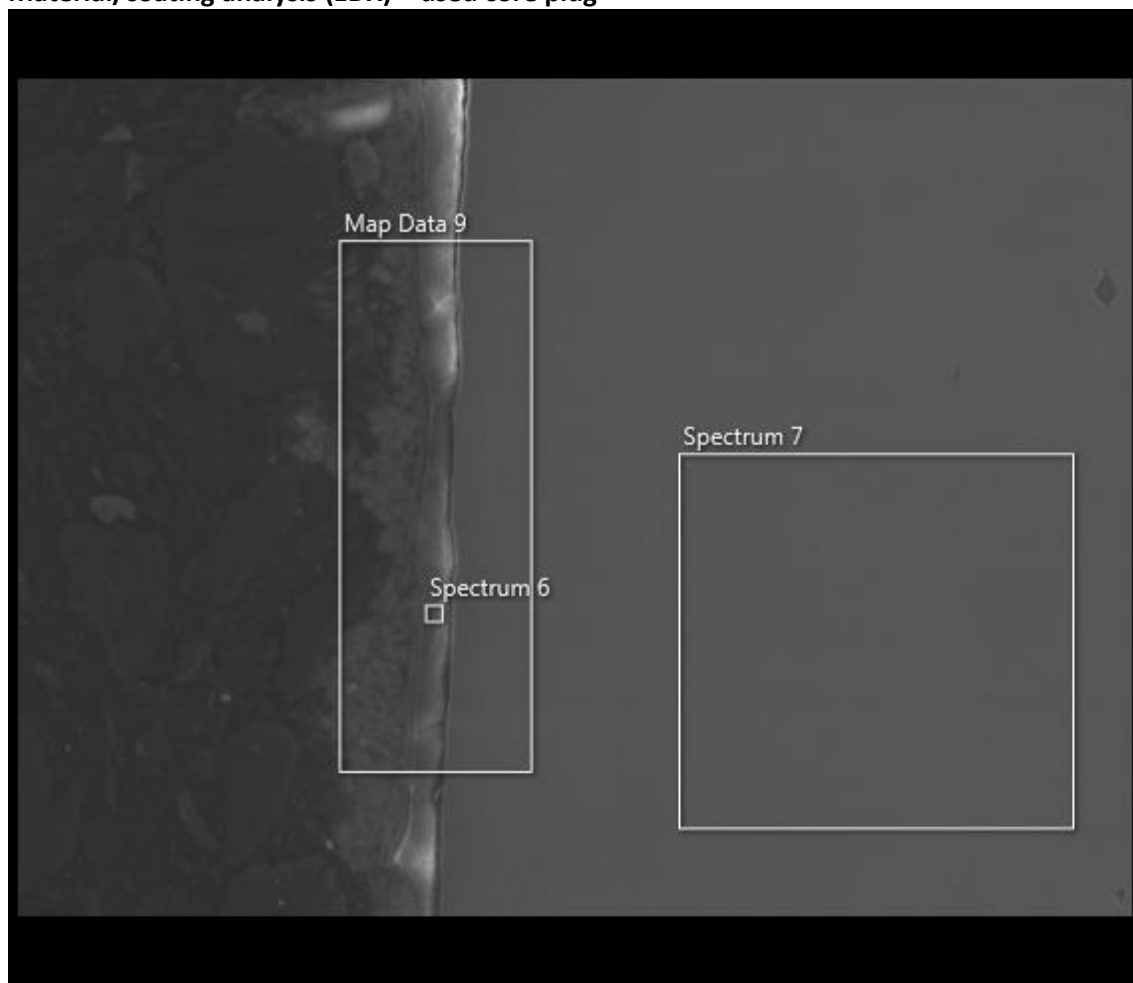
The cross section of a used core plug clearly shows a coating (see Annex 2). The chemical composition of the surface is mainly a copper-zinc coating. The chemical composition of the base material is mainly iron and carbon.

Material/coating analysis on the used core plug showed mainly iron and carbon, which means that the tested used core plug is probably made from normal mild steel. Furthermore, a thin corrosion protective coating consisting of copper and zinc of approximately 10 µm was also observed.

Figure 9: Cross section of used core plug magnified 4,000x.

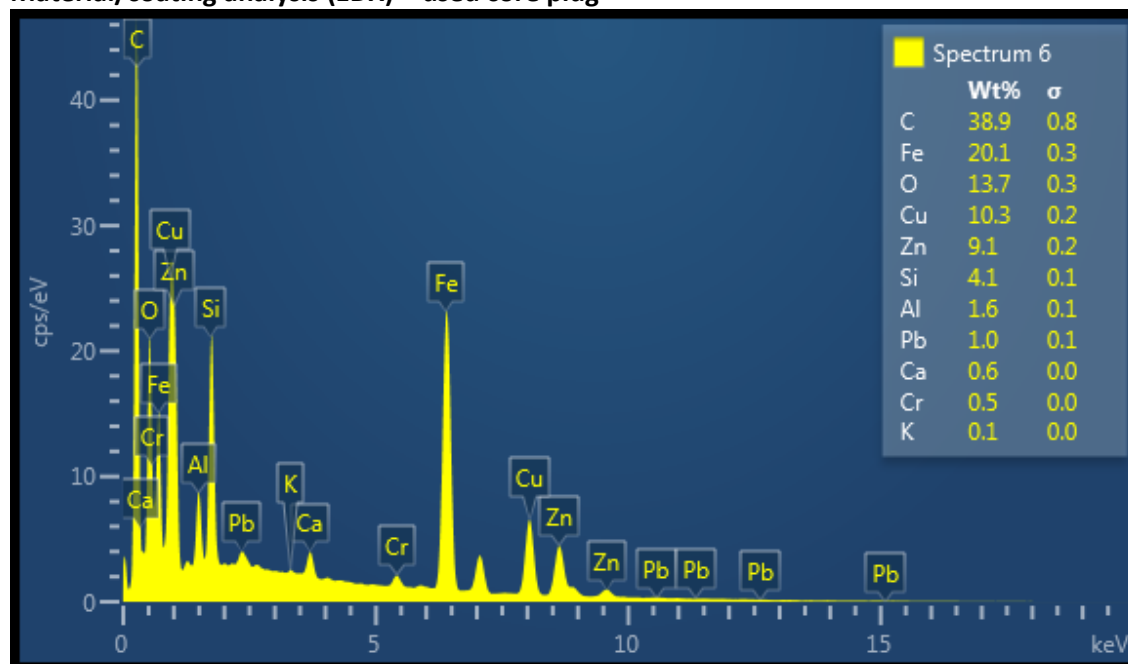
Figure 10: Spectrum of coating on used core plug.

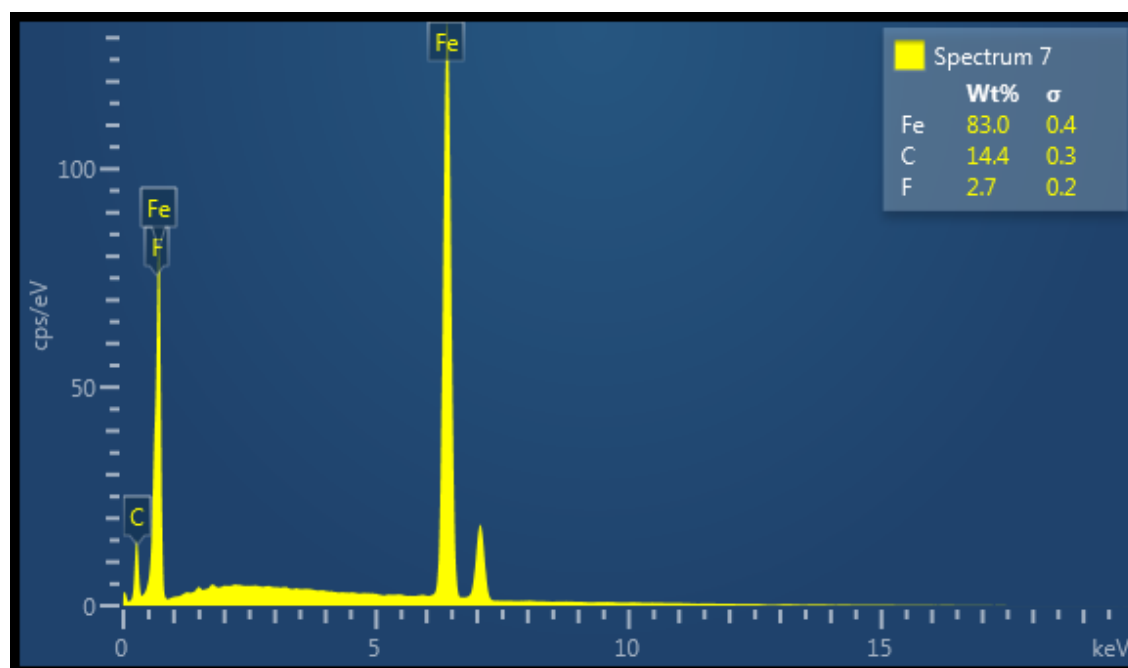
Figure 11: Spectrum of base material for used core plug

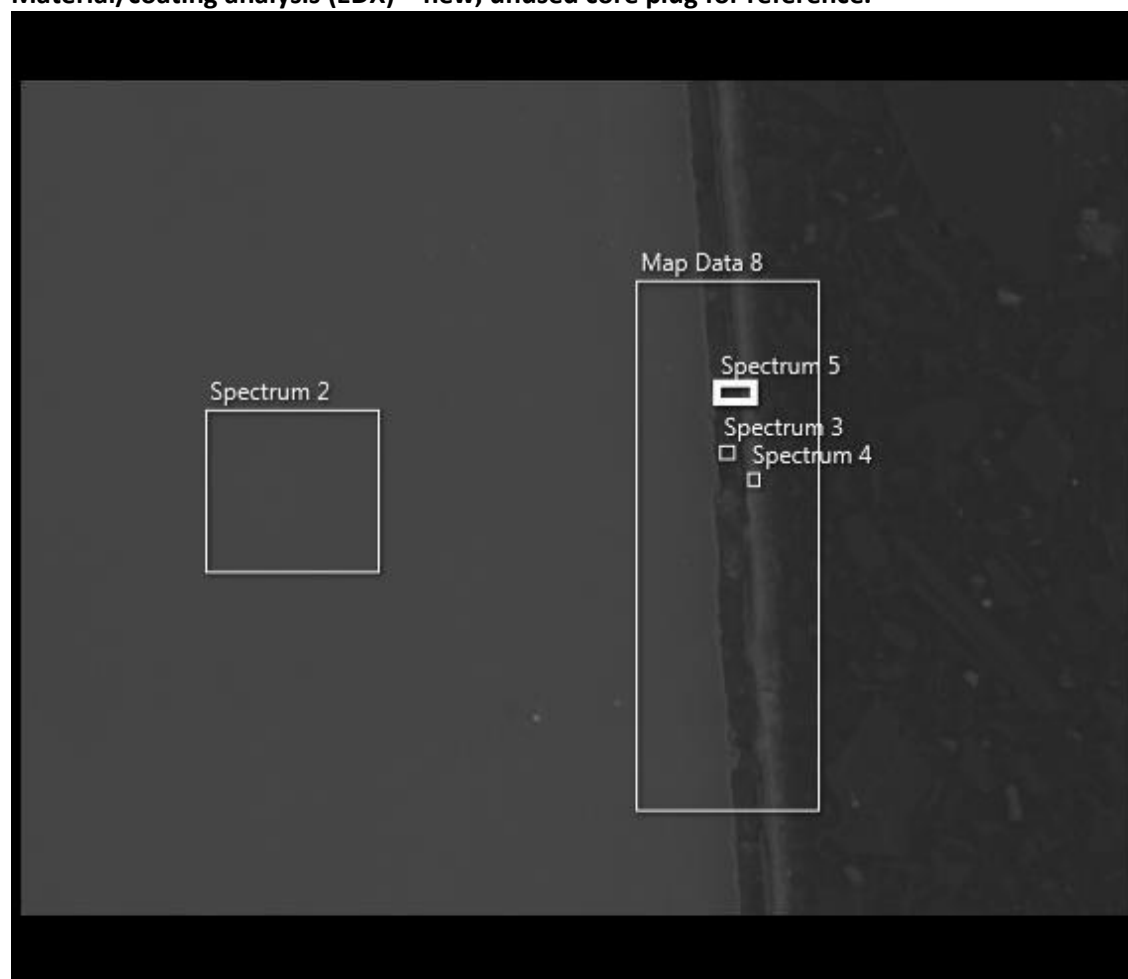
The cross section of the new, unused reference core plug clearly shows a surface coating (see Annex 3). The chemical composition of the surface is mainly a chrome-zinc coating. The chemical composition of the base material is mainly iron and carbon.

Material/coating analysis on the new, unused reference core plug showed primarily iron and carbon, which means that the new and unused reference core plug is probably also made from normal mild steel.

Furthermore, a thin corrosion protective coating consisting of chrome and zinc of approximately 10 µm was also observed.

Figure 12: Cross section of new, unused core plug magnified 4,000x.

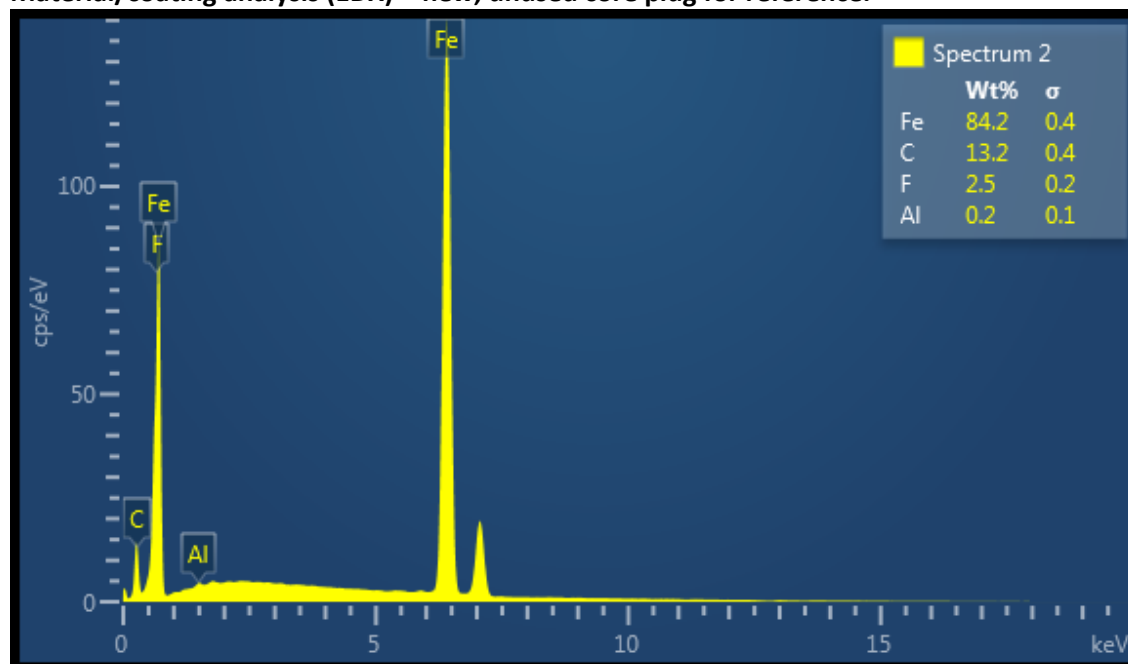
Figure 13: Spectrum of base material for new, unused core plug.

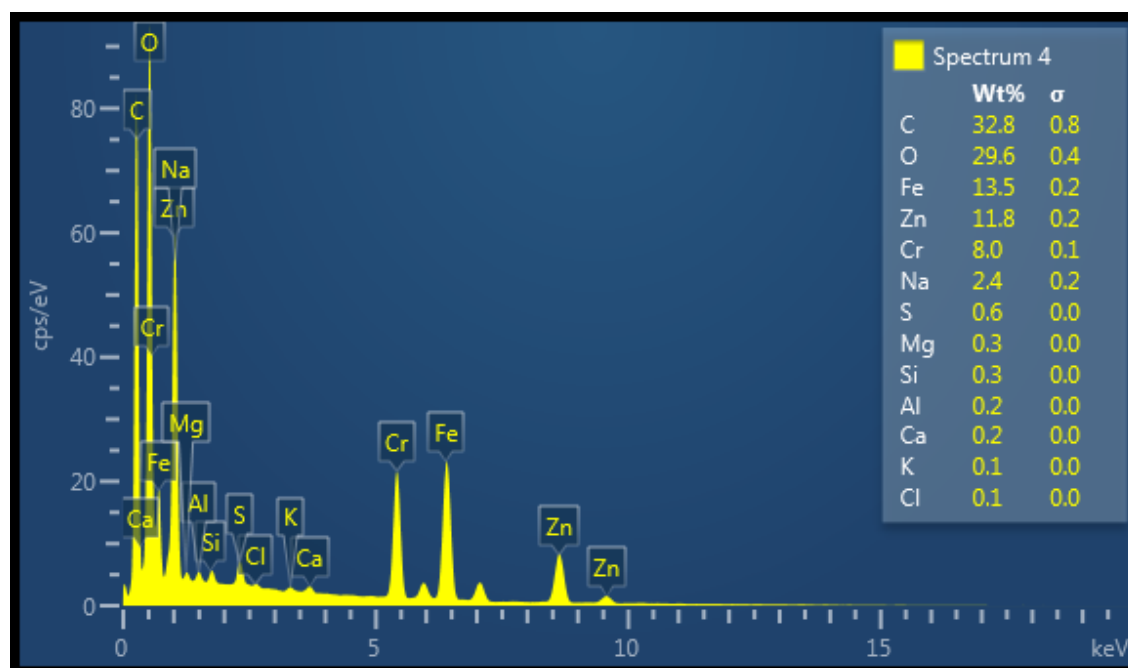
Figure 14: Spectrum of coating on new, unused core plug for reference.
