Report

Investigation of corrosion on core plugs on behalf of:

Dept. of Metal and Surface Engineering
Kongsvang Allé 29
DK - 8000 Aarhus C, Denmark
Phone: 7220 2000

02.10.2015

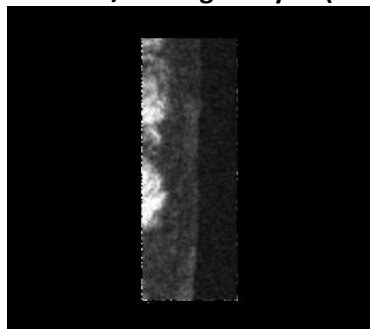
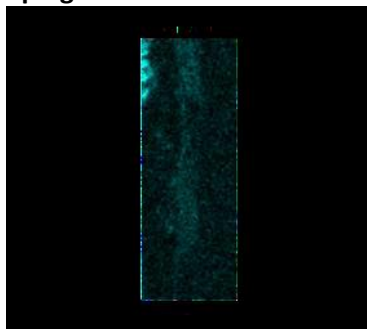
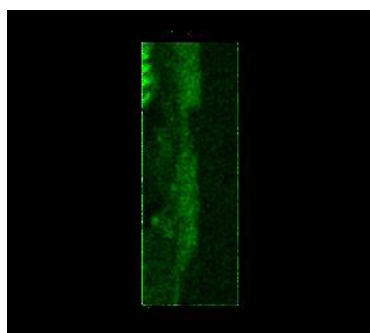
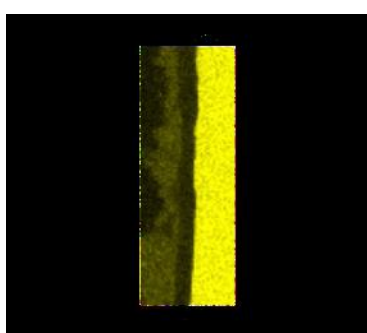
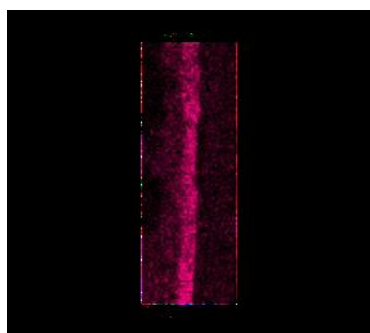
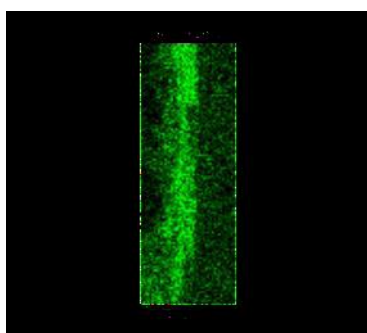
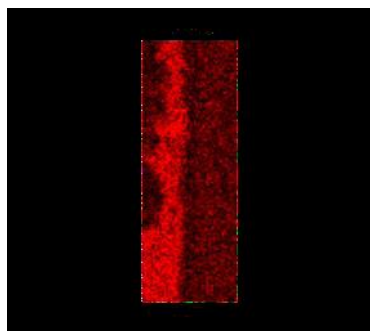
Annex 2.2

Material/coating analysis on the used core plug showed mainly iron and carbon, which means that the tested used core plug is probably made from normal mild steel. Furthermore, a thin corrosion protective coating consisting of copper and zinc of approximately 10 µm was also observed.

Material/coating analysis (EDX) – used core plug

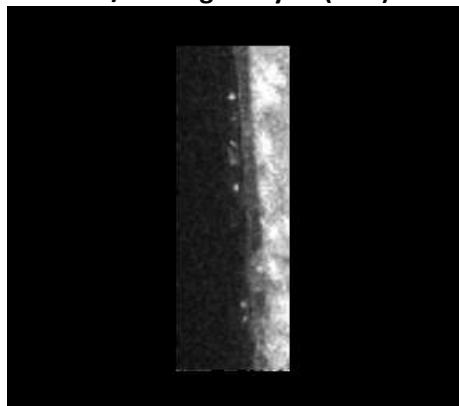
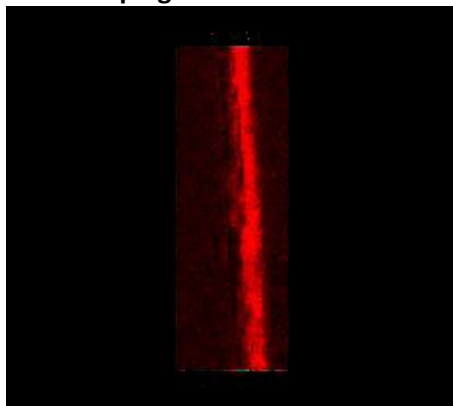
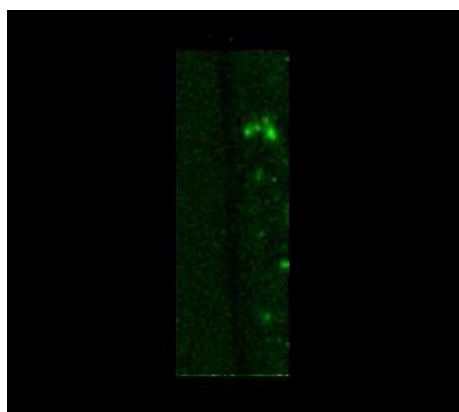
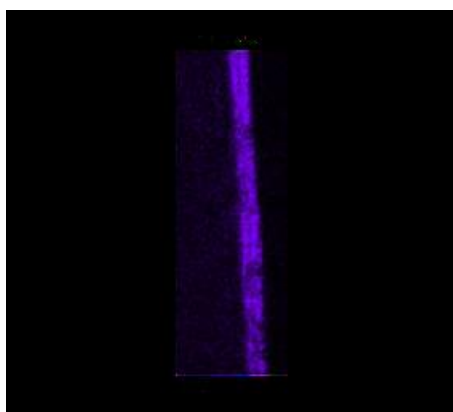
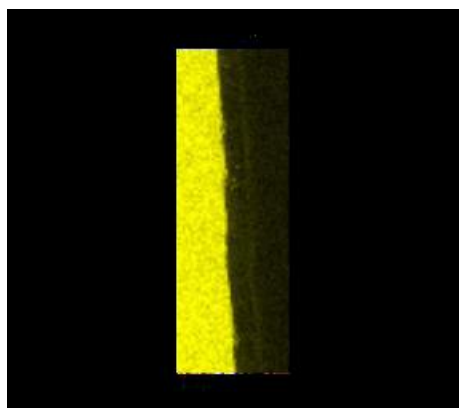
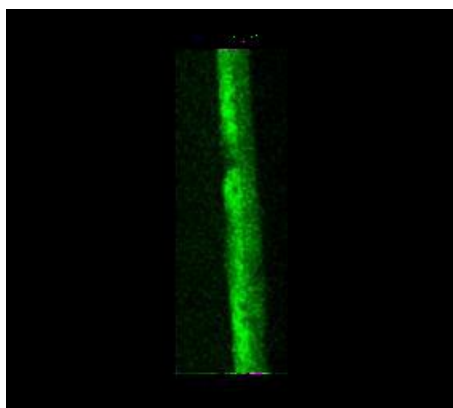
Annex 3.2

Furthermore, a thin corrosion protective coating consisting of chrome and zinc of approximately 10 µm was also observed.

Material/coating analysis (EDX) – new, unused core plug for reference.
